September 19, 2025

Interim Assessment of Kauai Beach Villas

WJE No. 2024.2062.1

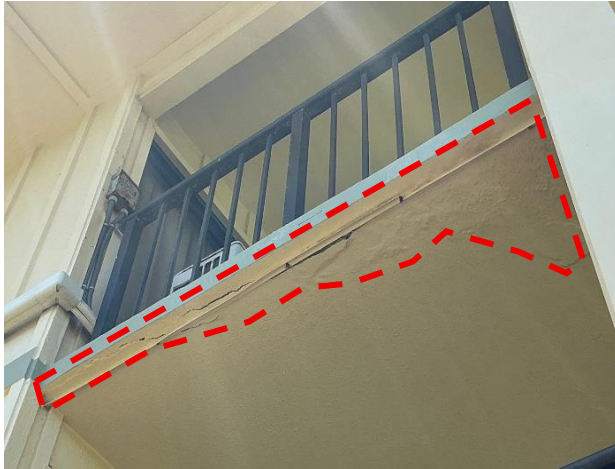
- **Cracked, delaminated, or spalled concrete** – Concrete deterioration in the form of cracks, delaminations and spalls is ongoing and additional distress was observed during this survey. Areas that appear to be loose or that could fall in the near term were found at most of the buildings (Figure 1 and Figure 2). Falling concrete presents a potential hazard to pedestrians below and should be removed immediately. Locations of loose spalls are listed below and are identified with red triangles in Appendix A with areas that present highest safety hazard further highlighted with a text annotation.

- Building A – Makai Stairwell, Units A12, A16 and A18 on Wailua Elevation and unit A17 on Lihue elevation.
 - Building B – Units B12 and B18 Makai Elevation and Unit B12 on Mauka Elevation.

Figure 1. Overhead Falling Debris Hazard, Unit A17.

- **Cracked, delaminated, or spalled concrete** - Due to the falling debris hazard posed by incipient spalling, the loose concrete pieces noted to require mitigation in the observations section of the report should be removed immediately. Access to the areas below should be restricted until the material is removed. Where possible, we recommend that other incipient spalls not noted as a falling hazards are also removed as they will become a hazard in the near term.

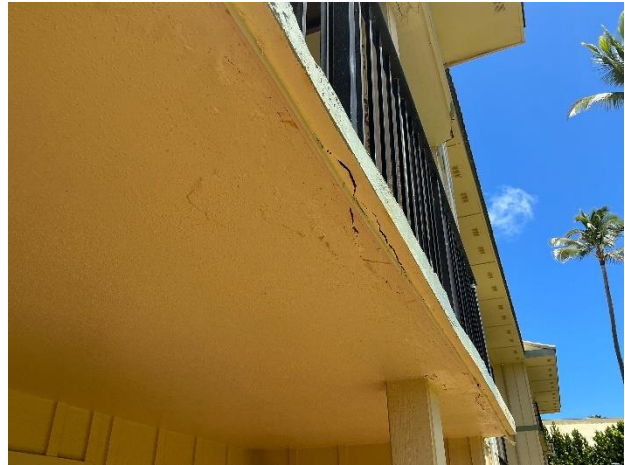
- Building C – N/A
 - Building D – Unit D21 Mauka Elevation, Units D15 and D16 on Lihue Elevation and units D6 and D15 on Wailua Elevation.
 - Building E – Unit E3 on Mauka Elevation, Unit E16 and stairwell on Makai Elevation, Units E11, E16 and E18 on Lihue Elevation and Units E4, E6, E9, E10 and E12 on Wailua Elevation.

Figure 2. Overhead falling debris hazard unit E16

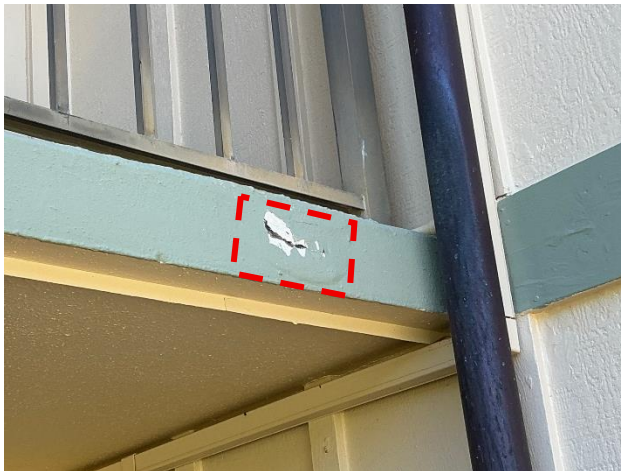
In addition to loose concrete identified above, new concrete deterioration, such as cracks or growth of existing concrete delaminations or spalls, were found throughout all the buildings. These areas are denoted by red revision clouds in Appendix A. Unit D9 was also noted to have two delaminations

consistent with possible post-tension cable breaks, identified with text annotations in Appendix A (Figure 3).

Figure 3. Delamination as a Result from PT Distress

Previous removal of delaminations have been successful in reducing the number of overhead debris hazards, as noted in previous reports. However, opening the existing spalls and exposing post-tensioning anchors has shown to cause additional deterioration to the post-tensioning system which increased future repair costs. Therefore, we strongly recommend that the deteriorated areas be repaired during the removal process, especially along slab edges. We also recommend that waterproof coatings be installed on all the lanais to prevent further ingress of chlorides and moisture.

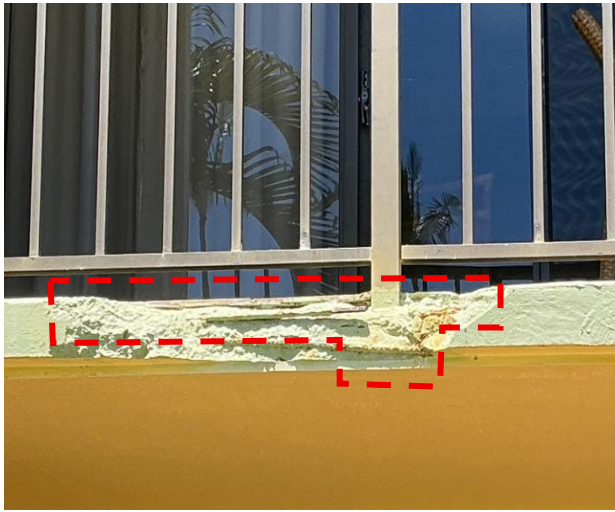
- Railings** – Railings that have reduced structural integrity due to concrete spalls at the railing posts or due to visible corrosion of the railing elements are present at all buildings observed (Figure 4, Figure 5 and Figure 6). Full depth section loss in the railing pickets is widespread in all buildings. Some isolated areas of full-depth section loss are also present at the railing posts. Based on observations, the section loss appears to be progressing from the inside out suggesting that internal corrosion of the railing is occurring. The observed section loss, evidenced by through-depth holes, has reduced the structural capacity of the affected elements. Some elements have either lost full or most of their cross-sectional area or have already dislodged and therefore have no effective structural capacity remaining (Figure 7).

Figure 4. Exposed Post Base Unit C16

- **Lanai Railing** - The guardrails are exhibiting systemic and widespread section loss due to corrosion and should be replaced as soon as possible. For guardrails containing through-depth and advanced corrosion or posts embedded in spalling or delaminated concrete, the affected lanais should be further evaluated for adequacy of the railing system by load testing or restricted from occupancy until retrofit repairs or railing replacements are implemented.

Railings with spalls at the rail posts or through depth holes at the posts may suddenly break or dislodge under applied lateral loads. We recommend load testing all affected railing posts with observed corrosion or spalled concrete at their base. Alternatively, retrofit connections can be installed to tie the top rail to the structure if the spall or corrosion occurs within one rail segment of the structure. Strap type retrofits used to secure the railing to the building should follow details provided in our letter report titled *Interim Assessment of Kauai Beach Villas* dated September 26, 2023.

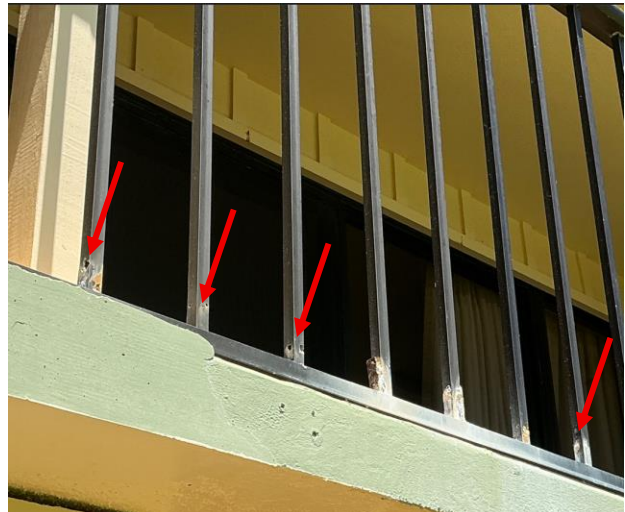
Figure 5. Typical Lanai Corrosion with full depth holes. Unit E10 shown.

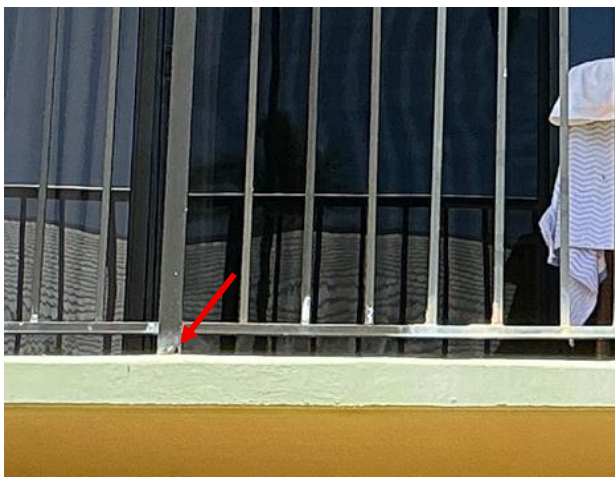
Figure 6. Hole at post unit E10 lanai

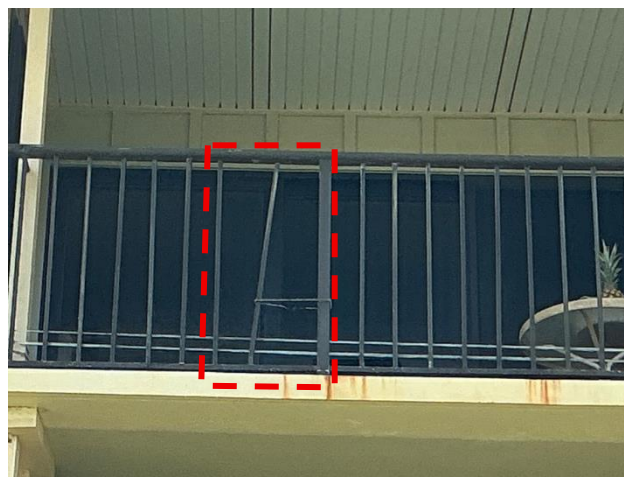
Figure 7. Missing picket at unit F12

Corrosion of the railing pickets has advanced and the integrity of the pickets is unknown where staining or full depth section loss is observed. Deteriorated pickets may dislodge or break suddenly

under normal service loads. Dislodged or broken pickets can allow pets or children to fall through the rails. Therefore, we recommend load testing at least two units with through depth corrosion at the pickets to determine their current capacity. Alternatively, retrofits can be installed at the pickets. Retrofits for the pickets will need to be designed by a licensed structural engineer and can be load-tested for proof of concept.

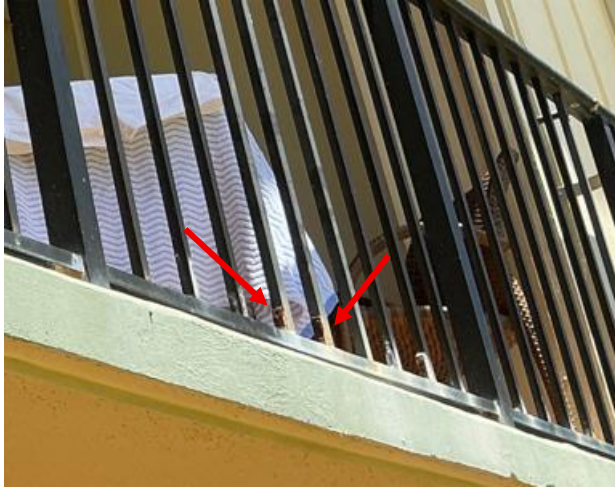
Some of the railing pickets have been retrofitted with metal angles and some of the top rails have been secured to walls, columns or previously installed shoring posts with metal straps or screws. Many of these retrofits are corroded or the fasteners between the strap and connected elements have failed (Figure 8 and Figure 9). Strap type retrofits with advanced deterioration have been identified with text annotations in Appendix A. Corroded picket retrofits are not specifically identified and are included in the picket distress annotation, purple rectangle in Appendix A.

Figure 8. Corroded angle retrofits installed at railing pickets at Lihue elevation of Building D.

Although retrofits can be effective in restoring capacity at the lanais noted in this report, they should not be relied on to provide a long-term solution. The short-term effectiveness of retrofits is demonstrated by the advanced corrosion observed at most installed retrofits. This is largely due to the use of mild steel angles and straps for the currently installed retrofits which corrode rapidly in the marine air. Even with proper material selection for the retrofit, aluminum or stainless steel, the fastener holes in the aluminum will corrode rapidly due to galvanic corrosion because readily available fasteners are generally stainless steel which cause accelerated corrosion of aluminum. Due to softness of aluminum, aluminum screws likely will not provide sufficient capacity to adequately secure retrofits to the railing.

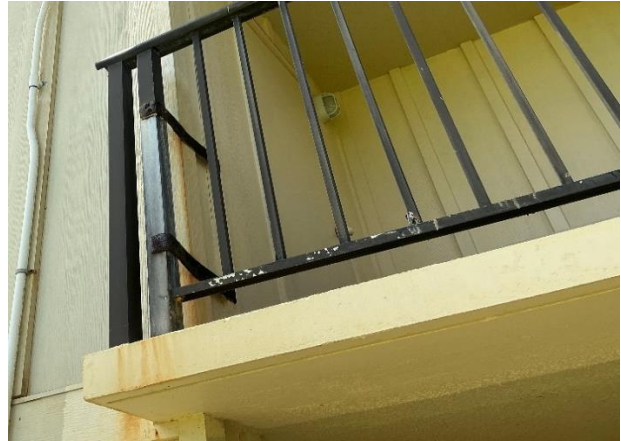
Figure 9. Corroded retrofit and full depth Holes due to Corrosion on Unit F3 Lanai

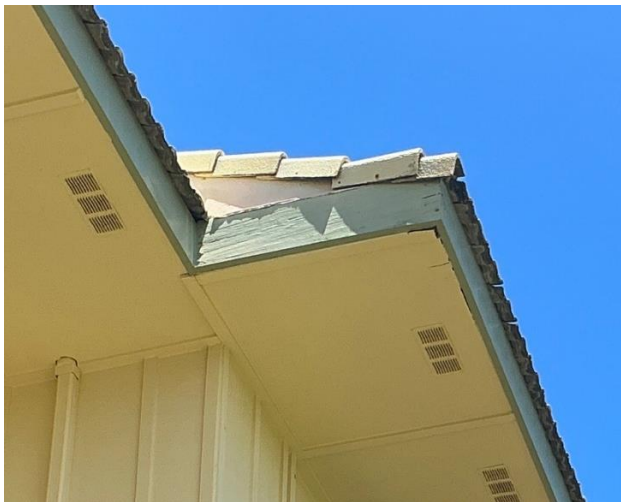
- **Roof Rakes** – Corrosion of the dowel-type ferrous fasteners at the roof rake overhangs is present at most of the roof tiles at the roof rake returns (Figure 10). Corroded fasteners have already caused roof tiles to fall. While most of the rakes have evidence of corrosion staining at the nail heads, given the concealed nature of the fasteners, failure of the fasteners due to corrosion may occur without visual evidence from the exterior.

Figure 10. Typical corroded nails at the roof rake returns. Lihue elevation at Building D shown.

- **Roof Rake Tiles** - We recommend replacement of the existing fasteners with 316 stainless steel fasteners.

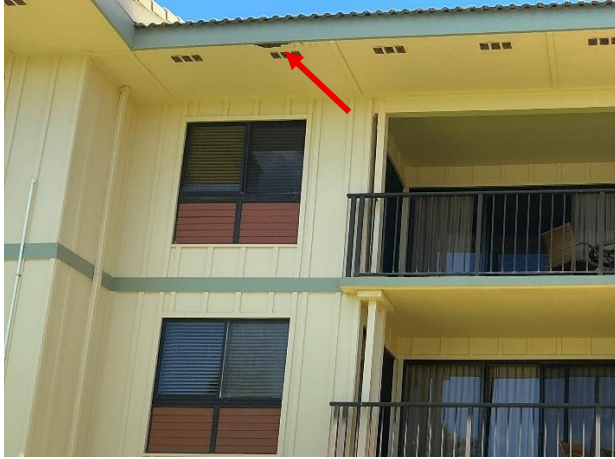
- **Soffit Panel Decay/Displacement** – Decay or displacement of the soffit panels is present in building D along the Lihue Elevation (Figure 11). The decayed locations are identified in Appendix A with text annotations. Decay of soffit panels suggests the areas are getting wetted, which may affect the

connection of the panels to the structural framing. Soffit panels with similar conditions have previously fallen from building G. Falling panels are a safety hazard to pedestrians below.

Figure 11. Decay of soffit panel at Lihue elevation of building D.

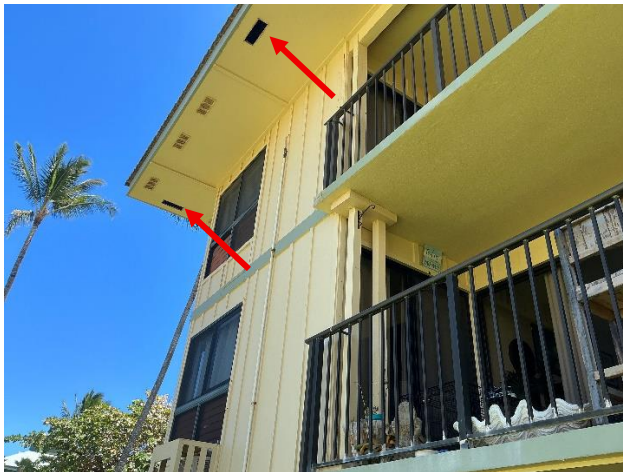
- Missing Vent Covers** – Three vent covers are missing from the soffits at Building A and one from Building E. While these conditions do not currently pose an immediate operational concern, falling vent covers suggests that the fasteners used to secure them have failed, likely from corrosion, allowing the vent cover to fall. Falling vent covers can present an overhead debris hazard to pedestrians. In addition, vent covers limit pest ingress into the attics and, therefore, should be replaced. Missing vents are indicated in Appendix A with text annotations.

Figure 12. Missing vent covers at Building A. Condition is similar at other locations.
